Demonstration of Aquafix and SAPS Passive Mine Water Treatment Technologies at the Summitville Mine Site

Innovative Technology Evaluation Report

EPA/540/R-04/501
June 2004

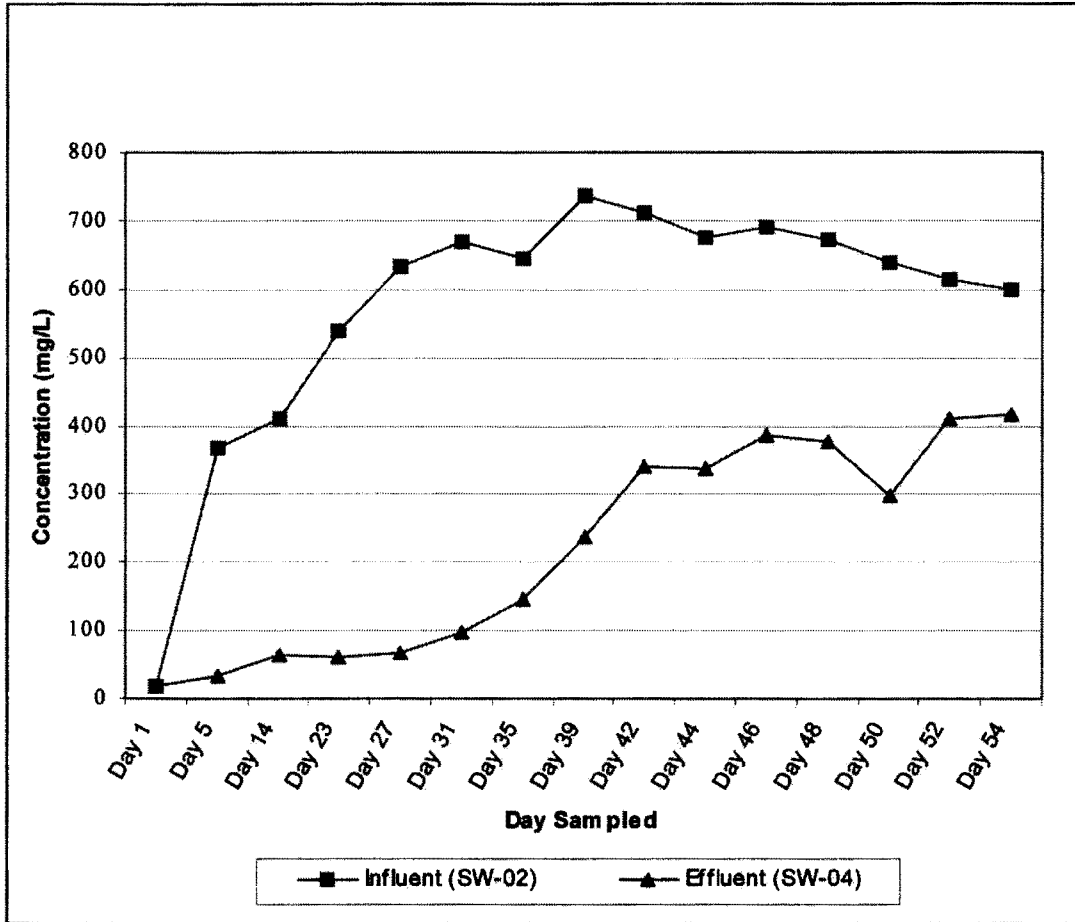
Figure 1c. SAPS System, Iron

Month/Day	Influent Concentration (mg/L)	Effluent Concentration (mg/L)*	% Reduction
Day 1	17.4	18.1	0
Day 5	369	33	91.1
Day 14	412	65	84.2
Day 23	537	59.5	88.9
Day 27	632	67.7	89.3
Day 31	669	97.7	85.4
Day 35	645	147	77.2
Day 39	735	236	67.9
Day 42	712	340	52.3
Day 44	674	339	49.7
Day 46	692	386	44.2
Day 48	672	378	43.8
Day 50	640	298	53.4
Day 52	613	412	32.8
Day 54	600	417	30.5

*Effluent sample collected four days after influent sample to accommodate pond residence time.

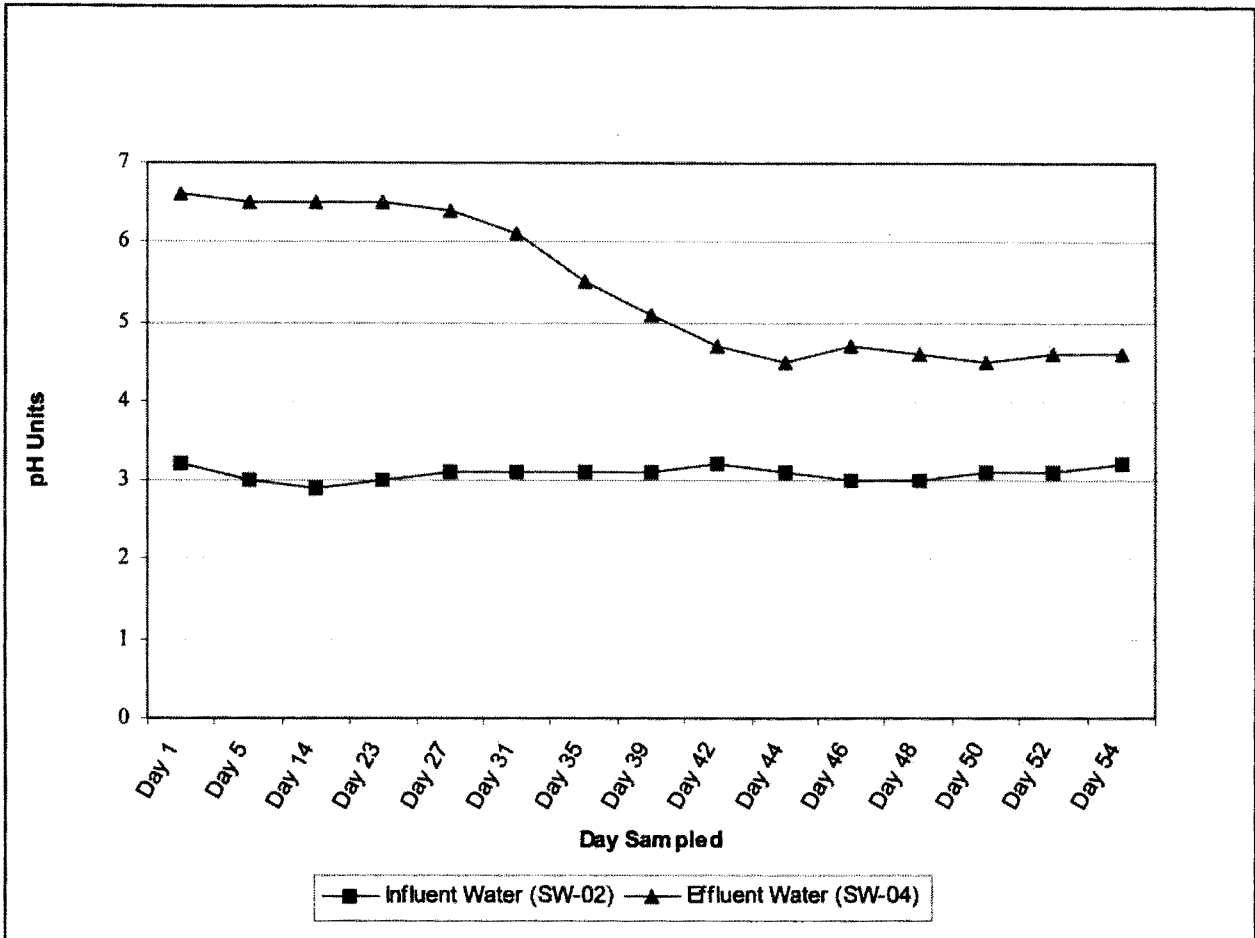
Figure 1f. SAPS System, pH

Month/Day	Influent pH	Effluent pH*	pH Unit Increase
Day 1	3.2	6.6	3.4
Day 5	3.0	6.5	3.5
Day 14	2.9	6.5	3.6
Day 23	3.0	6.5	3.5
Day 27	3.1	6.4	3.3
Day 31	3.1	6.1	3.0
Day 35	3.1	5.5	2.4
Day 39	3.1	5.1	2.0
Day 42	3.2	4.7	1.5
Day 44	3.1	4.5	1.4
Day 46	3.0	4.7	1.7
Day 48	3.0	4.6	1.6
Day 50	3.1	4.5	1.4
Day 52	3.1	4.6	1.5
Day 54	3.2	4.6	1.4

*Effluent sample collected four days after influent sample to accommodate pond residence time.

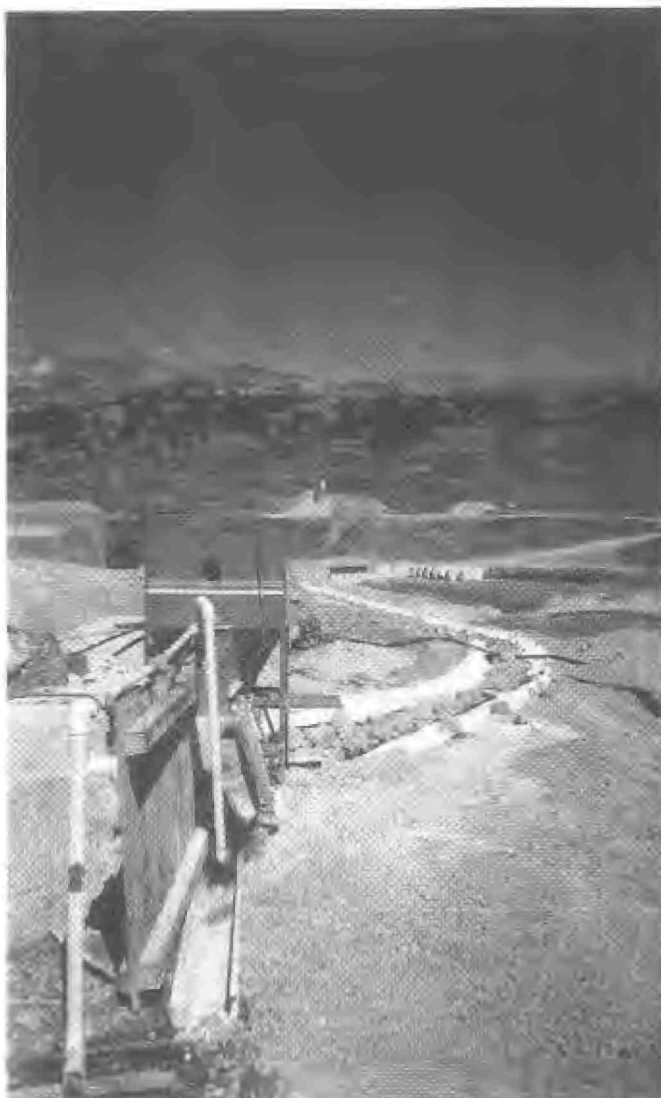
Aquafix System as set up at Summitville.

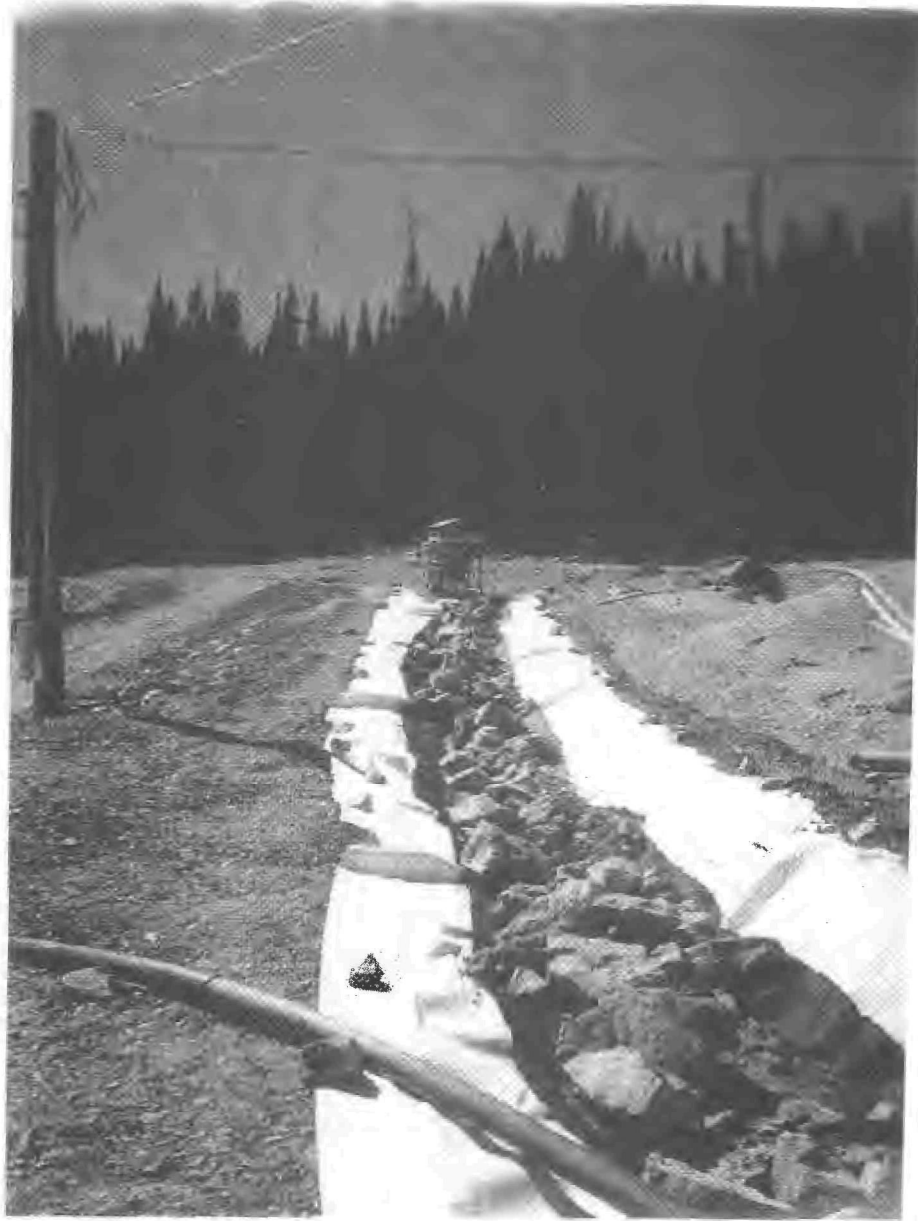
Photograph shows rock trench and plastic liner in foreground and Aquafix system in background.
